STRUCTURAL EVALUATION OF UH-1D TUBULAR
ROTOR BLADE

Fiber Science, Incorporated

Army Air Mobility Research and
Development Laboratory

August 1974

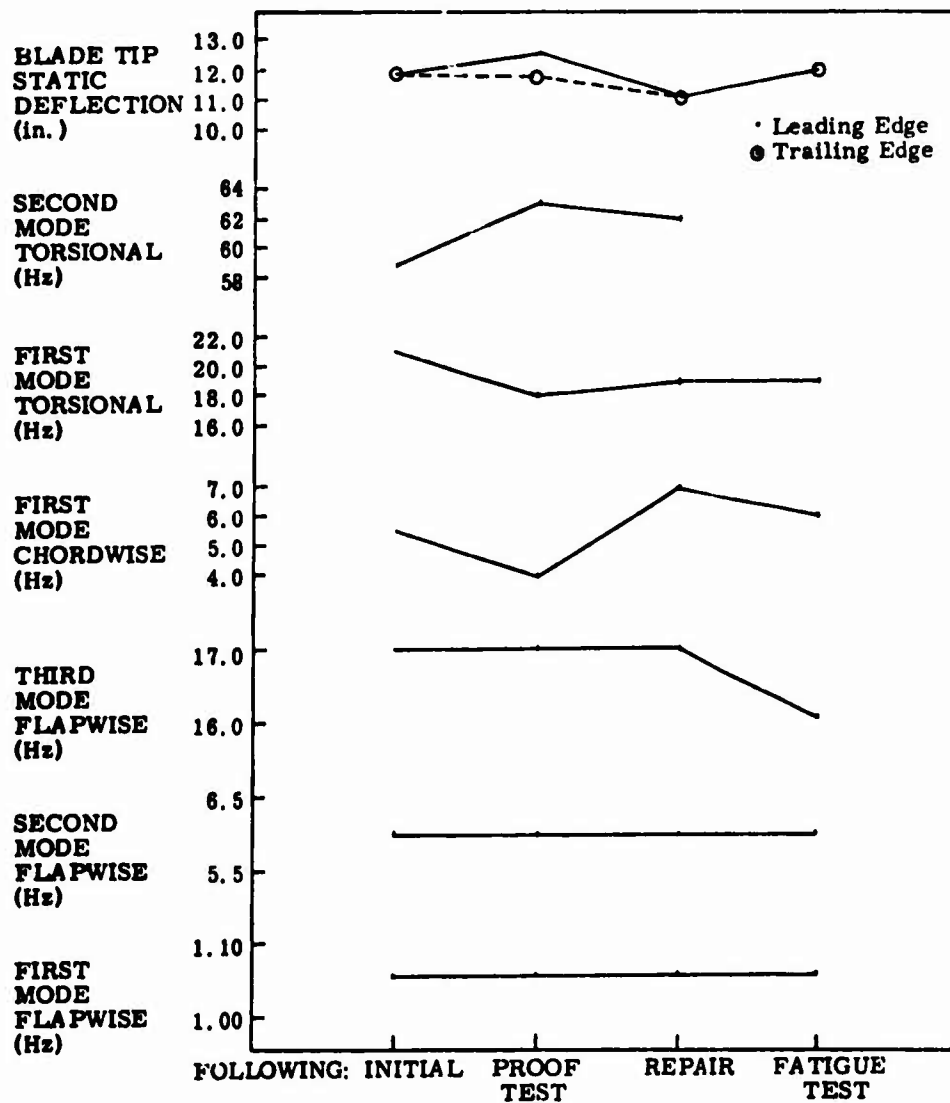
Figure 24. Static Deflection and Natural Frequencies Versus Test Sequence - S/N 001.

The flapwise, chordwise and torsional static deflection data is summarized in Tables 4, 5, and 6. Figures 24, 25 and 26 show graphically the measured deflection data plotted versus the test sequence number. The minor differences in the data from static deflection and creep tests are due largely to the inability to repeat the same test conditions from one test to the next.

There was a perceptible change in the blade stiffness resulting from the failure during chordwise proof testing of S/N 001 and leading and trailing edge bullet impact of S/N 002. Subsequent repairs restored the blades to their original conditions.

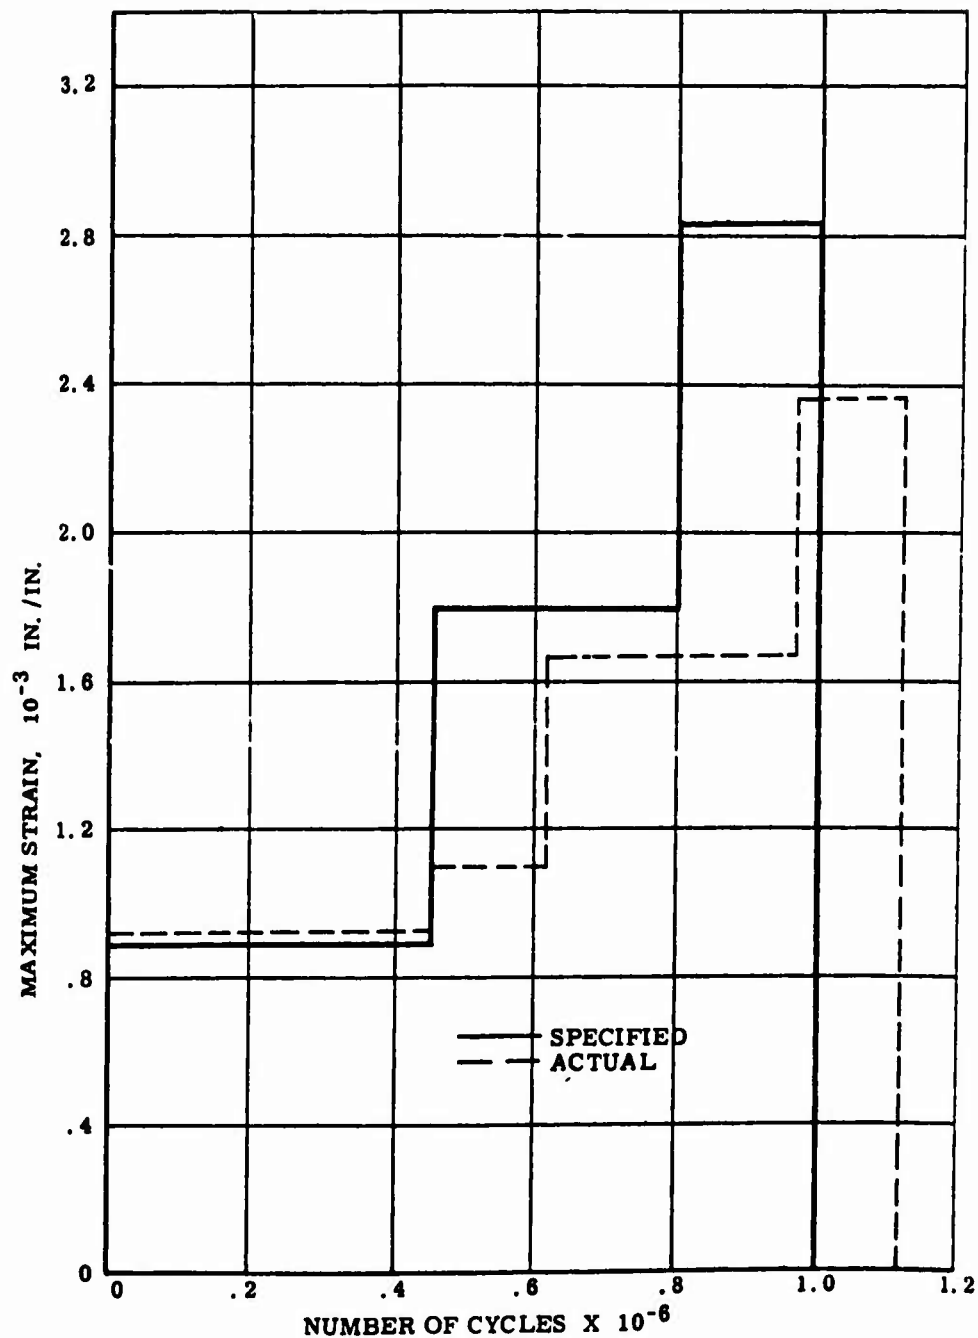
Figure 29. Fatigue Test Strain Levels Versus Number of Cycles - S/N 002.

Blade S/N 002 withstood 450, 000 cycles at a strain of +.000920 in. /in., 167, 076 cycles at a strain of +.001200 in. /in., 350, 000 cycles at a strain of +.001670 in. /in., and 29, 376 cycles at a strain of +.002360 in. /in. The +.001200 level was performed in error. At 29, 376 cycles of the high level (+.002360 in. /in. strain) test, a fatigue failure appeared in the root end 5 inches from the center of the 2.5-inch pin hole toward the blade tip (see Figure 31). Testing was continued for an additional 116, 000 cycles until failure progressed to the point where vibration could no longer be effectively induced. A total of 1.112×10^6 cycles was accumulated on the blade. The blade natural frequency in this mode was 17 Hz before the failure. After the failure, it was 15 Hz and gradually reduced to 13 Hz when the test terminated.

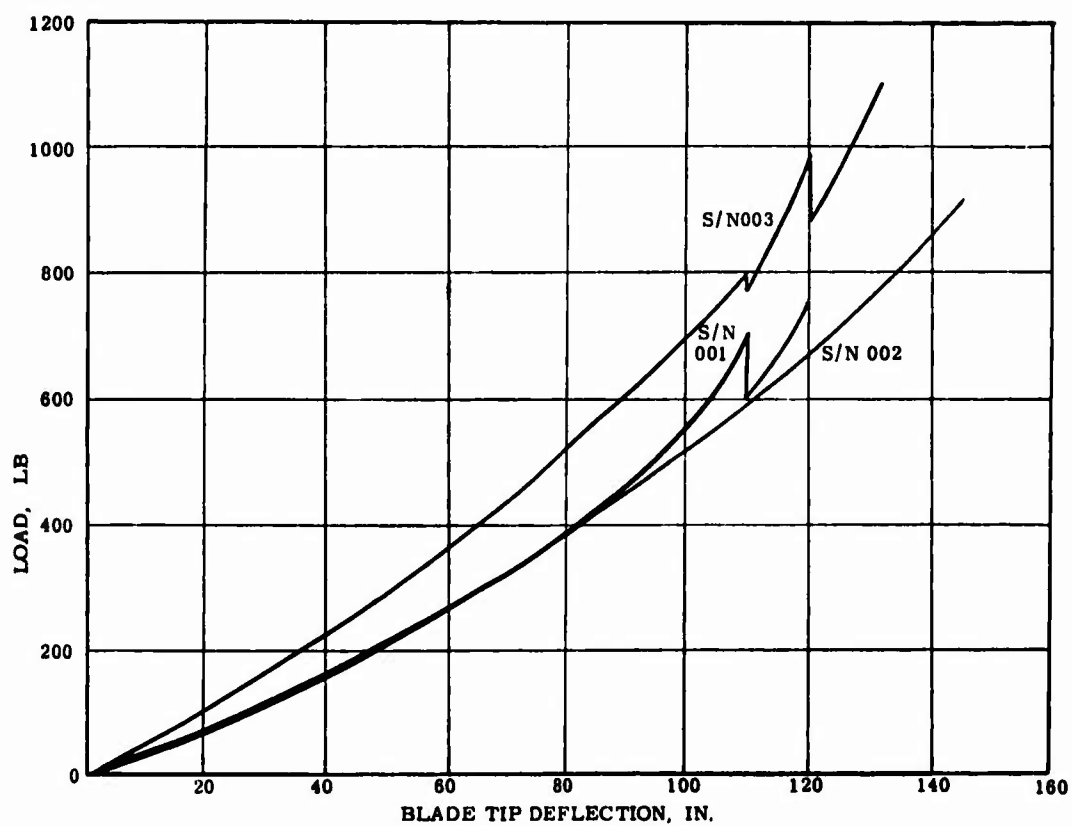
Figure 32. Load Versus Tip Deflection - Ultimate Beamwise Test.

The blade tip deflection (average of leading and trailing edges) versus load is shown in Figure 32.

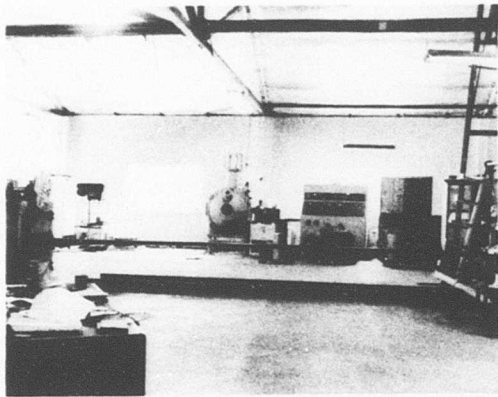
Figure 33. Ultimate Test -
Typical Zero
Position.

S/N 001 failed at a tip height (leading edge) of 10 feet above the zero position with a loading of 750 pounds. Failure occurred in the root end beginning at the damaged area incurred during fatigue testing. The failure line began at the center of the 2-1/2-inch-diameter hole, progressed straight to the leading edge, made an abrupt right angle turn at the seam in the leading edge, and progressed toward the tip for about 2-1/2 feet. The load after breakage dropped to 600 pounds (see Figures 33 and 36).
